# Manhole Inspection Summary

Manhole # S17E1\_005MH

Insp Date: **5/14/08 11:03 AM**

**Location** Address: **2025 inverness av**

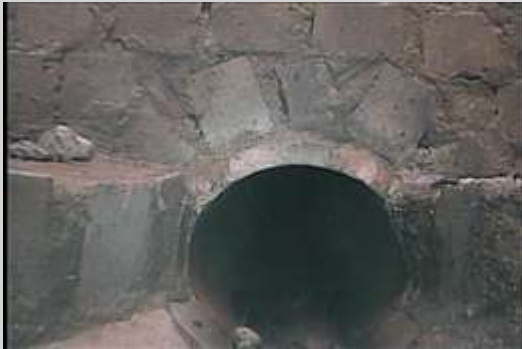
12 O'Clock Outflow

8 in. Circular Gravity Sewer  
Pipe Out @ 12 O'Clock

Pipe Height: **8.4** (in.) Rod and Bar (Angled)  
Pipe Material: **Clay** ☐ Pipe Lined  
Invert Depth: **7.73** (ft.) Flow Characteristics: **Slow**  
Deposits: ☒ None ☐ Mud ☐ Sludge ☐ Debris ☐ Grease  
Silt Depth: **0** (in.) Deposits Extent:  
Infiltration: **None** Pipe Seal Cond: **Sound**

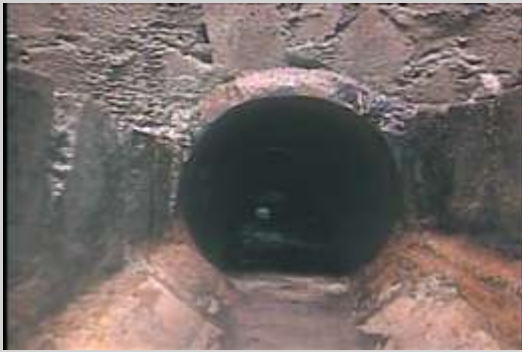
6 O'Clock Inflow

8 in. Circular Gravity Sewer

Pipe In @ 6 O'Clock

Pipe Height: **8.4** (in.) Rod and Bar (Angled)

Pipe Material: **Clay** ☐ Pipe Lined

Infiltration: **None** Pipe Seal Cond: **Sound**
